Noel Nathan Memorial Lecture in Structural Engineering  
The Canterbury Earthquakes - Engineering Matters

Dr David C Hopkins  
Consulting Engineer Wellington New Zealand

Vancouver  
30 May 2012

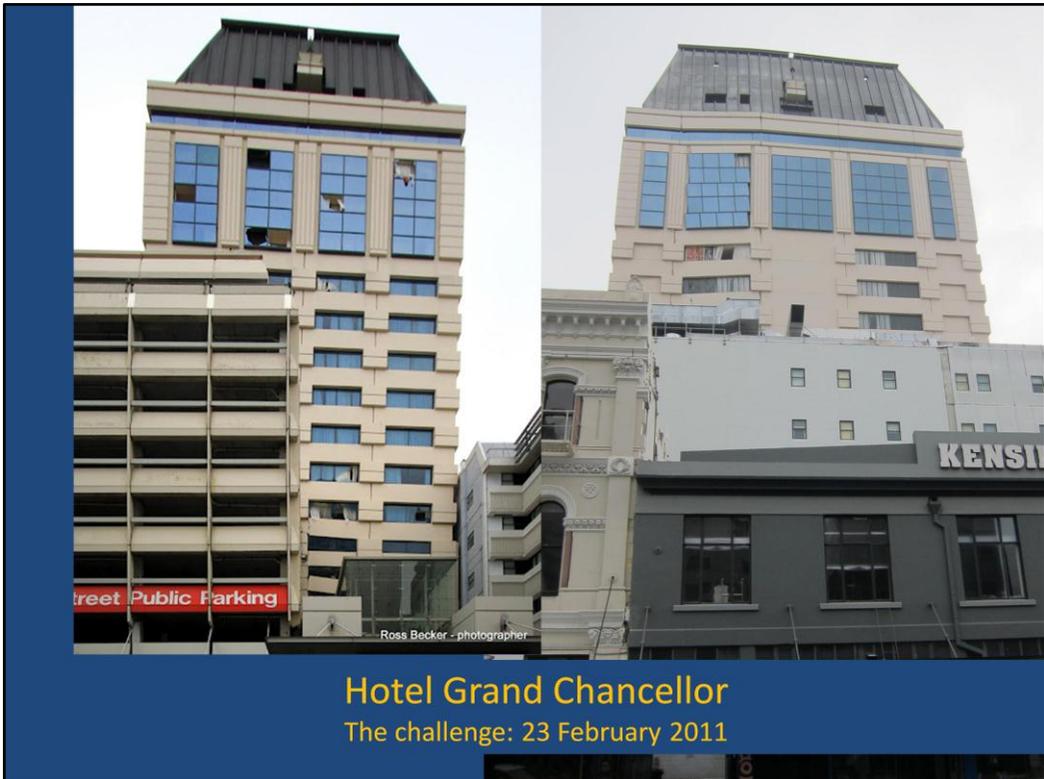
*HGC The Challenge 23 February 2011*

... from the east, it was clear that there had been a substantial drop in the south-east corner.

Was this structural or foundation failure?

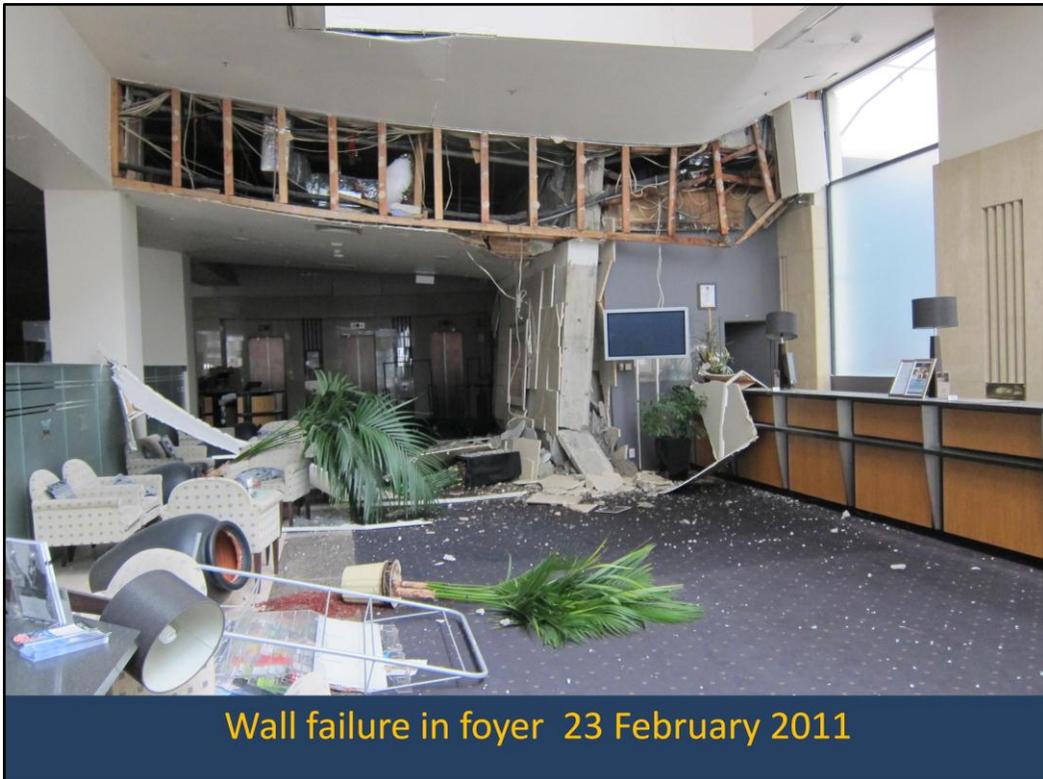
### *Wall failure in foyer*

The entry foyer offered a fundamental clue. A wall column had failed and the structure had dropped 800mm at that location.

(Until drawings were found, it was not known that this was supporting a cantilevered bay.)

An initial proposal, developed by Bruce Galloway, in a hand written evaluation and proposal, was to pump concrete to surround failed wall. This would be without any formwork to avoid risk to personnel.

Closer inspection showed that the whole wall including the top of the foyer section would need to be stabilised

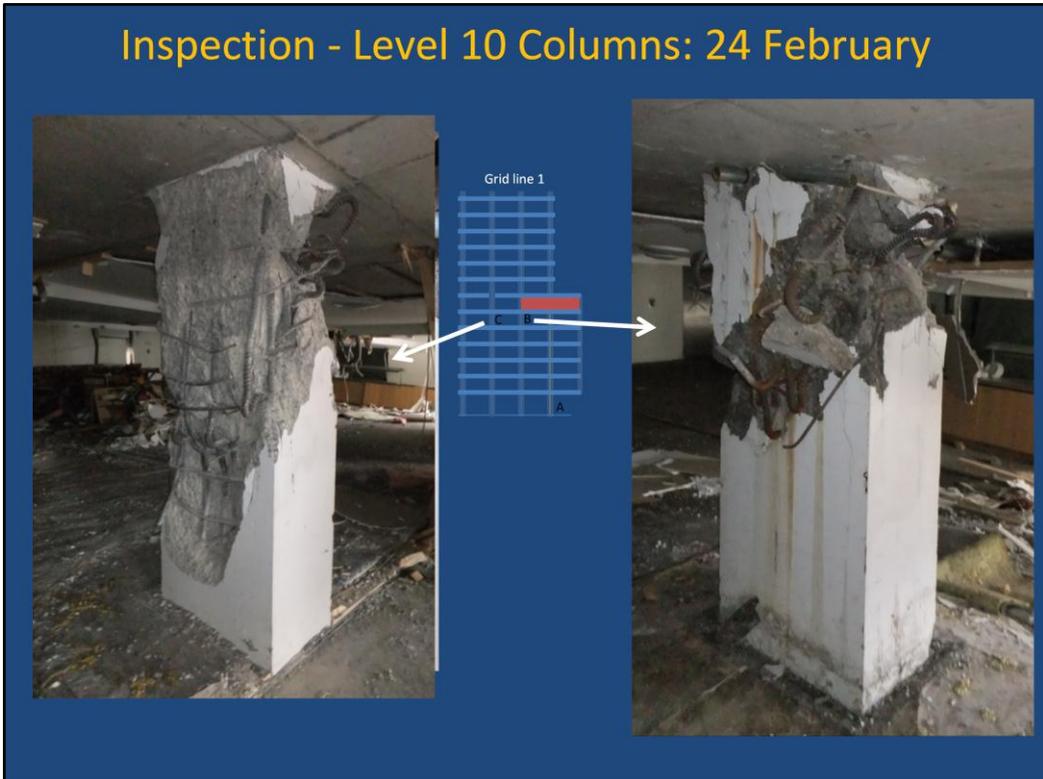
### *Inspection Level 10 Columns*

The 800mm drop in the shear wall in the foyer caused the storey-height cantilever to rotate and drop. Something else had to give. It was columns on Level 10.

It was as well that the failed wall was still carrying load – and stopped further collapse.

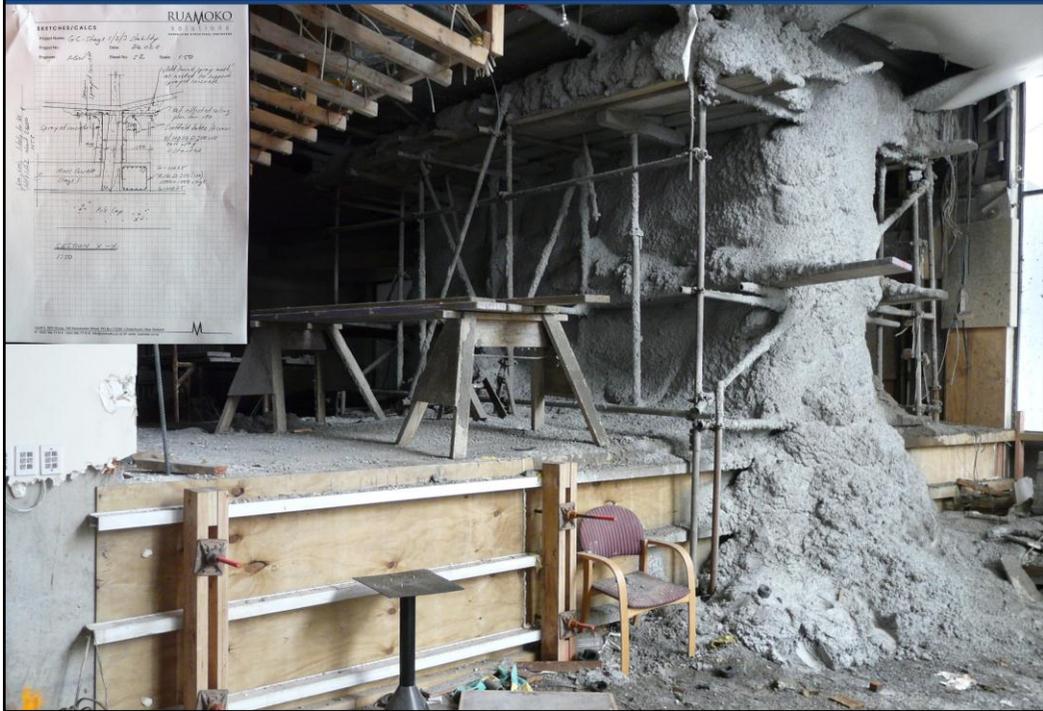
### *Completed Ground Floor Repair*

There were no reprisals or requests for re-work when it was found that the dimensions of the real thing differed from those on the drawings.

The general consensus was that this part of the structure would not fail.

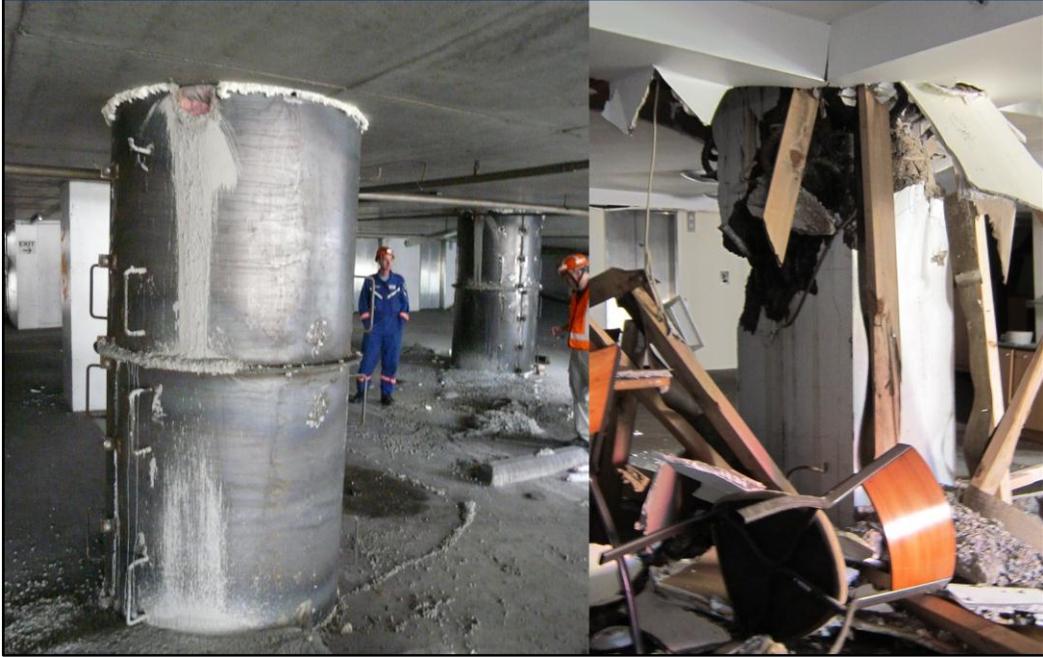
*Columns Level 10 and Repair*

These pictures show a damaged column at Level 10 (right) and a jacketed column (left) (not the same one)

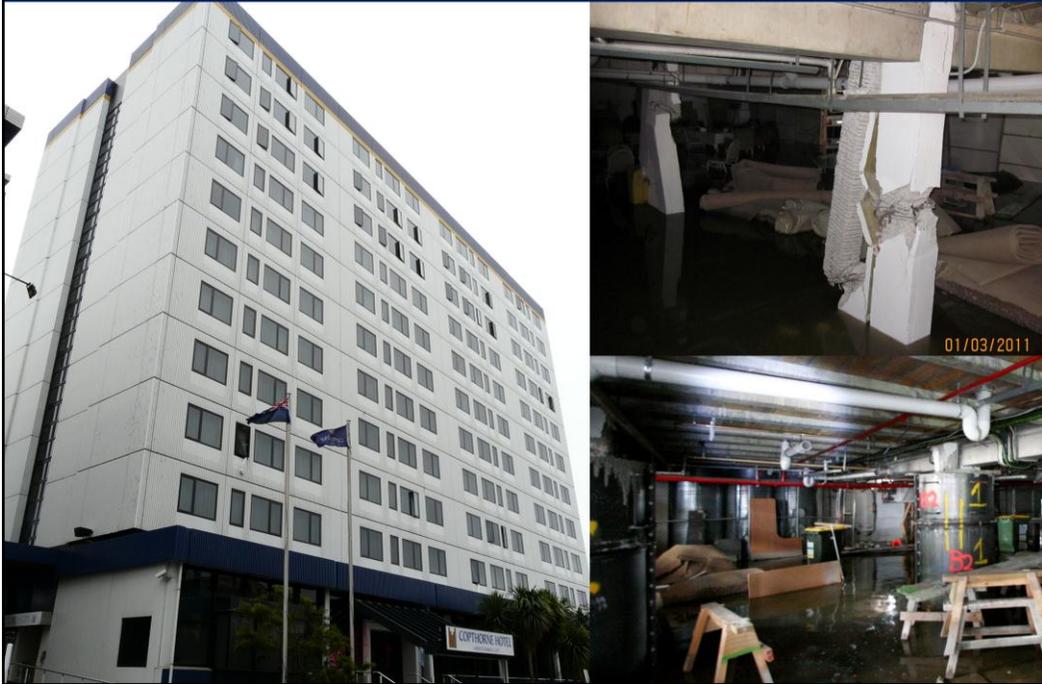
*Copthorne Hotel Durham St*

This hotel had critical damage to basement columns.

The danger required major road closures and denial of access to many important buildings nearby which were not so badly damaged.

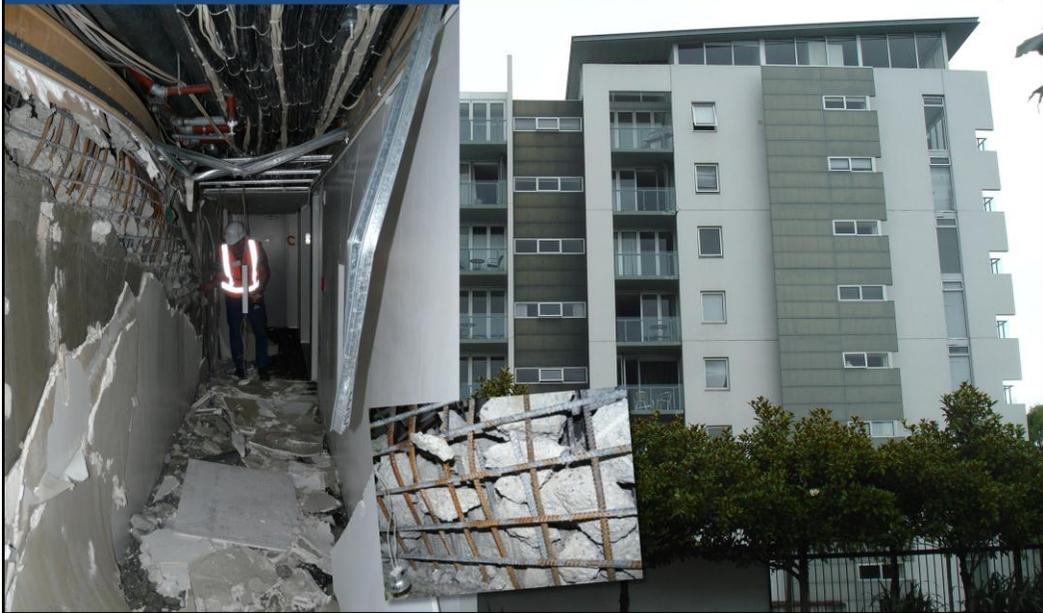
### *Park Terrace Apartments*

A major shear wall failed in this block of apartments – one of five similar ones in the development

(This and similar blocks in this development have been demolished after further damage to them in the aftershock of 23 December 2011.)

Repairs were devised that enclosed the damaged portions of shear wall with reinforced concrete either side.

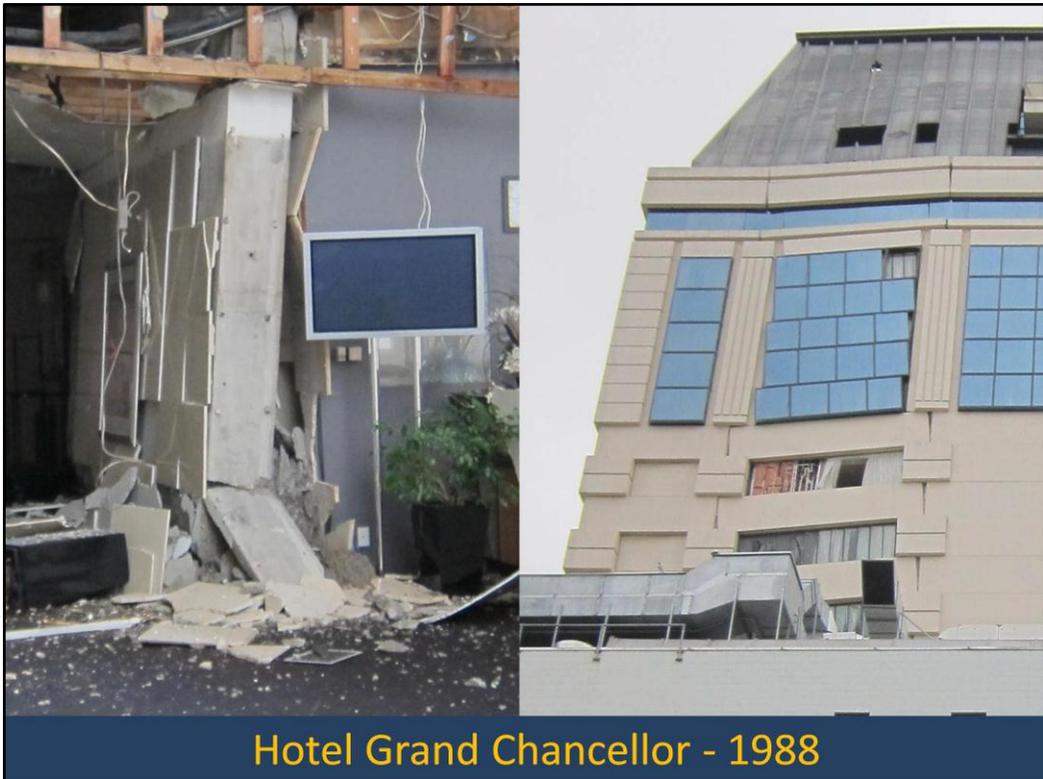
*Hotel Grand Chancellor – 1988*

The investigation showed that the failed wall in the foyer was under particularly heavy stress and that this may have been compounded by torsional movement and secondary effects of the storey-height cantilevers.

The strong vertical components of acceleration in this earthquake may have caused higher compression forces than would otherwise have been the case.

Improved detailing of the wall may have prevented its failure, even in the intense shaking.

The stair failure was determined to be due to the collapse of the wall.

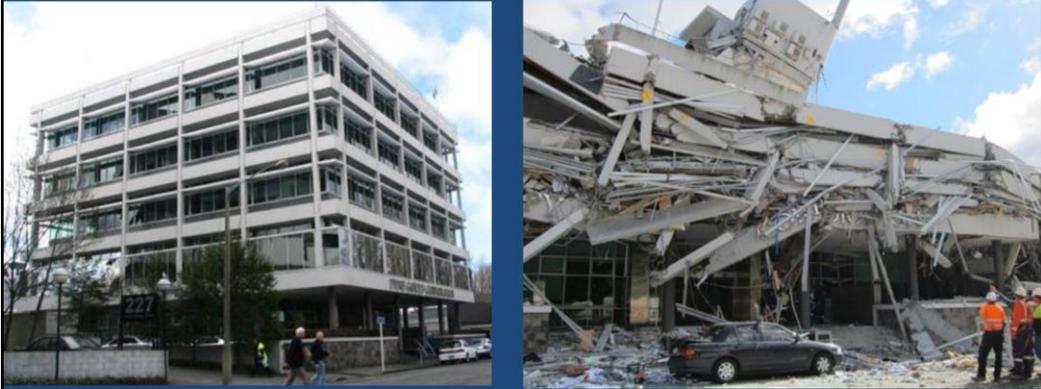
### *PGC Building 1963*

The investigation found that the intense shaking caused failure of the east core wall. Excessive displacements were then caused on the gravity columns which can be seen in the photograph.

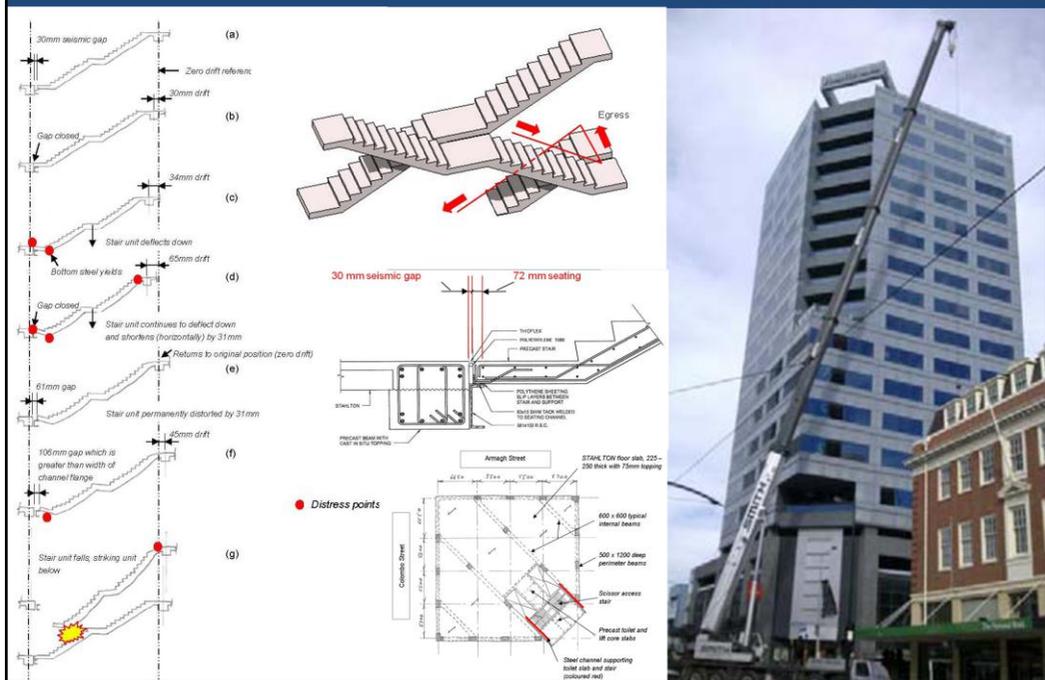
*Forsyth Barr Building - 1988*

This building survived well overall with comparatively little structural or non-structural damage.

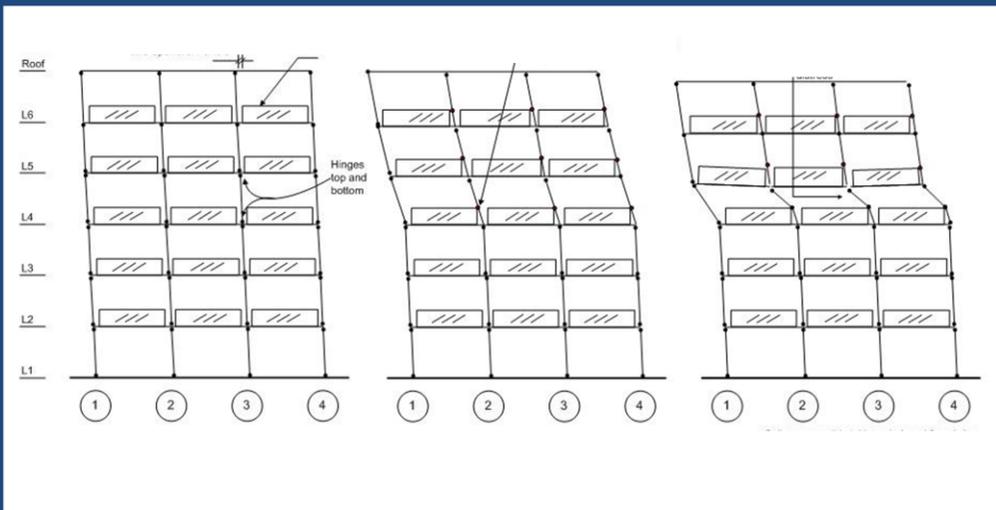
East wall column or columns fail

(The spandrel panels may have restrained the movement and caused early column failure.)

Once one column failed, others quickly followed.

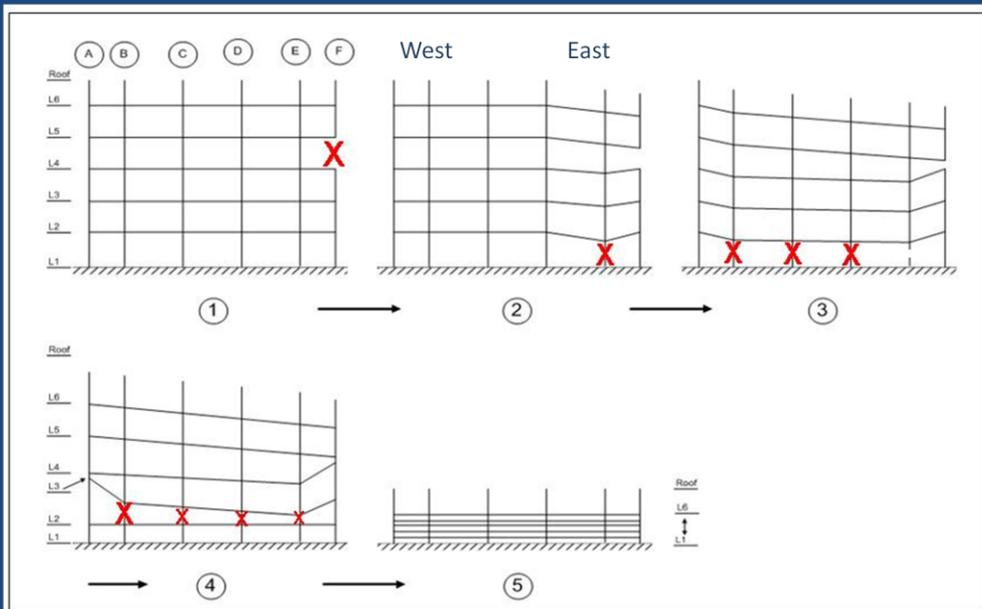
### Possible collapse scenario – view from south

1. East columns fail as just described
2. Weight transfers to internal columns and causes failure of one of these at a low level
3. Failure spreads rapidly to adjacent columns
4. Slabs and beams drop, distorting the columns. Column failure spreads
5. The floors collapse onto one another, particularly in the sections to the south.

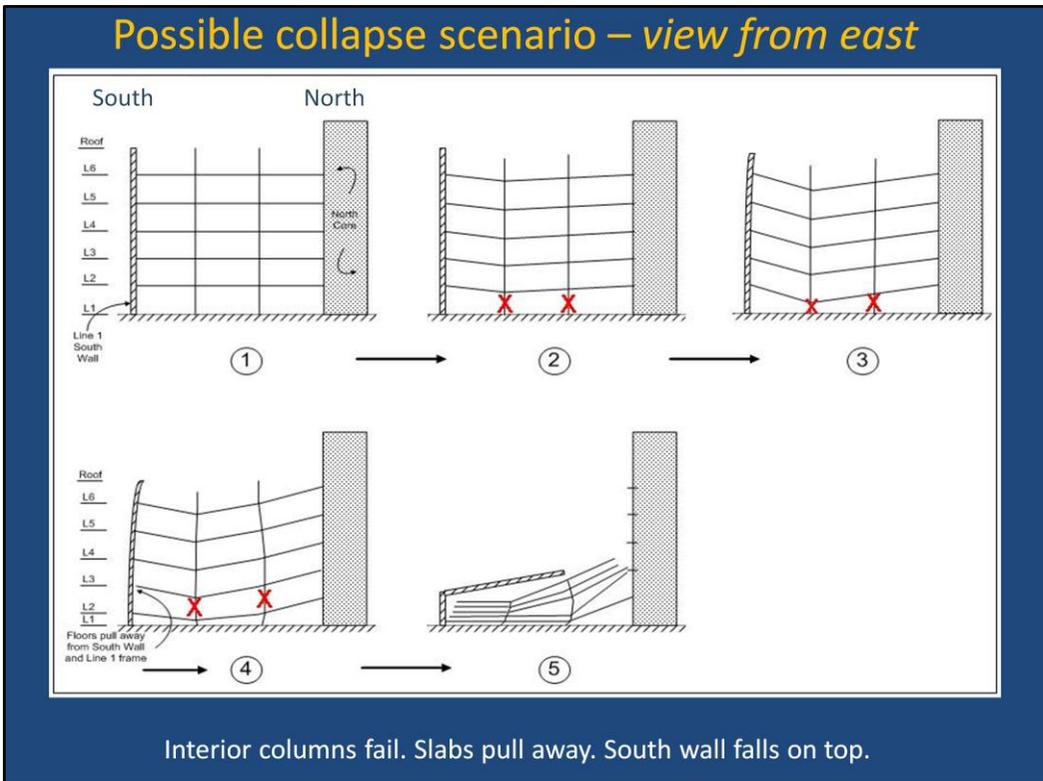
*Possible collapse scenario – view from east*

1. East wall columns fail – no visible effect on internal columns, but load increases on them
2. Internal columns fail at low level
3. Floors drop, distorting and straining the remaining columns and beams
4. More columns fail and the floors start to pull off the north core and south wall
5. Floors collapse. South wall pulled over on top of slabs

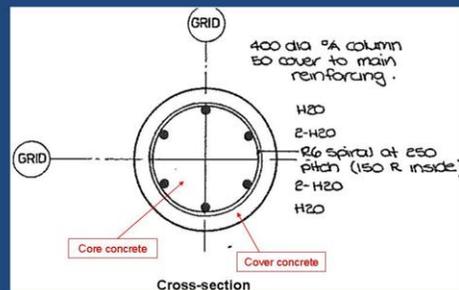
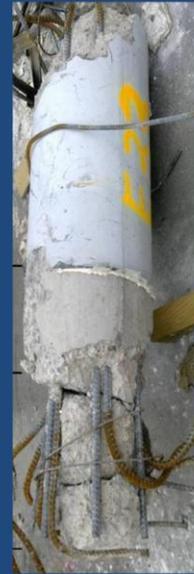
### *Reinforcing details in columns*

- Very low “confinement” steel
- Less movement capability
- Brittle not ductile
