Noel Nathan Memorial Lecture in Structural Engineering  
The Canterbury Earthquakes - Engineering Matters

Dr David C Hopkins  
Consulting Engineer Wellington New Zealand

Vancouver  
30 May 2012

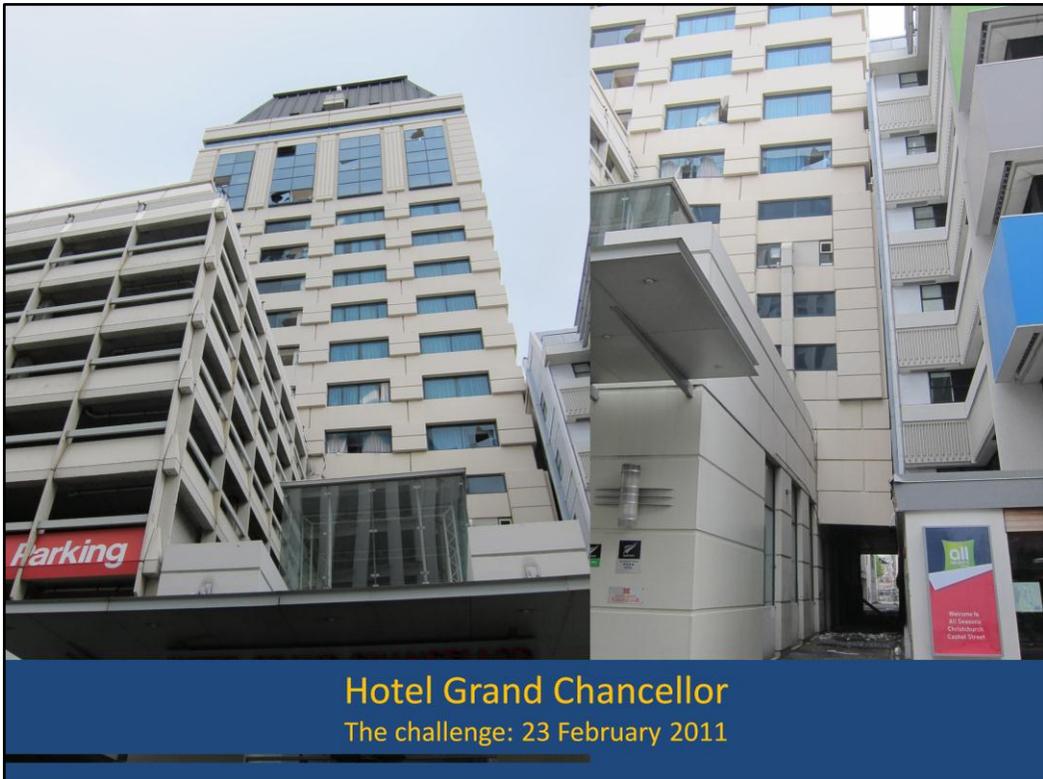
*HGC The Challenge 23 February 2011*

Standing “downstream” of the lean was not a comfortable feeling on 23 February.

No-one knew at that stage that one quarter of the building was cantilevered over Tattersall’s Lane (see right photo.)

The appearance of this south wall offered few clues and .....

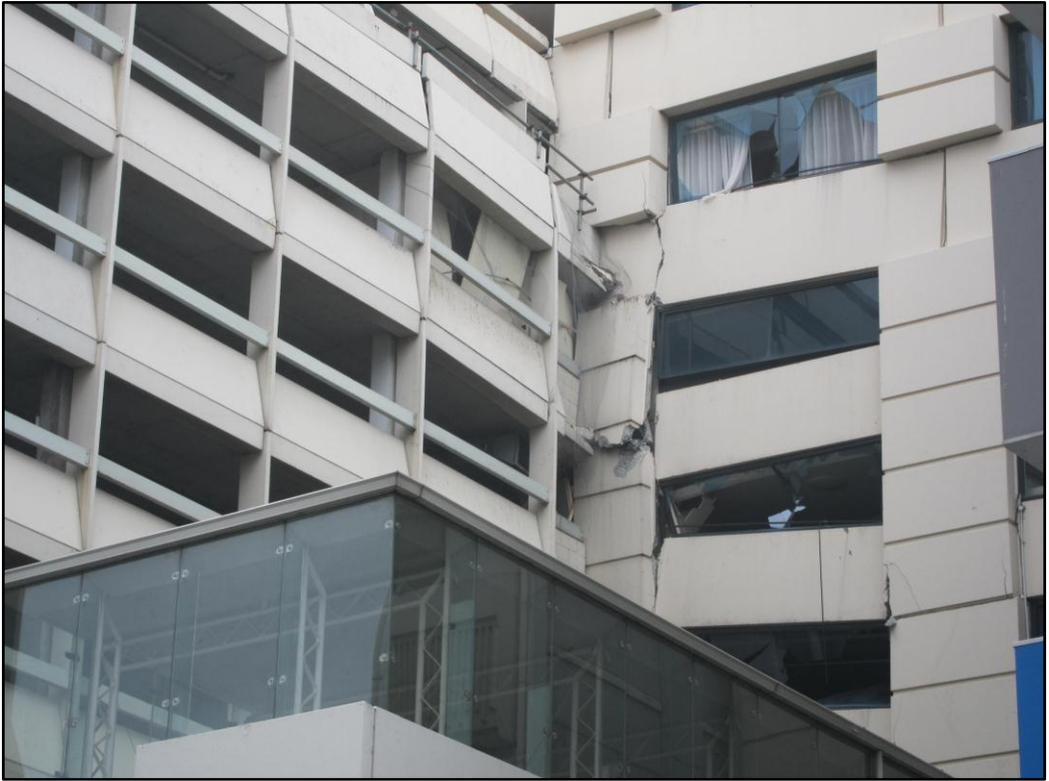
*South Wall Close-up*

.....looking closer did not help much., but ....

Was this structural or foundation failure?

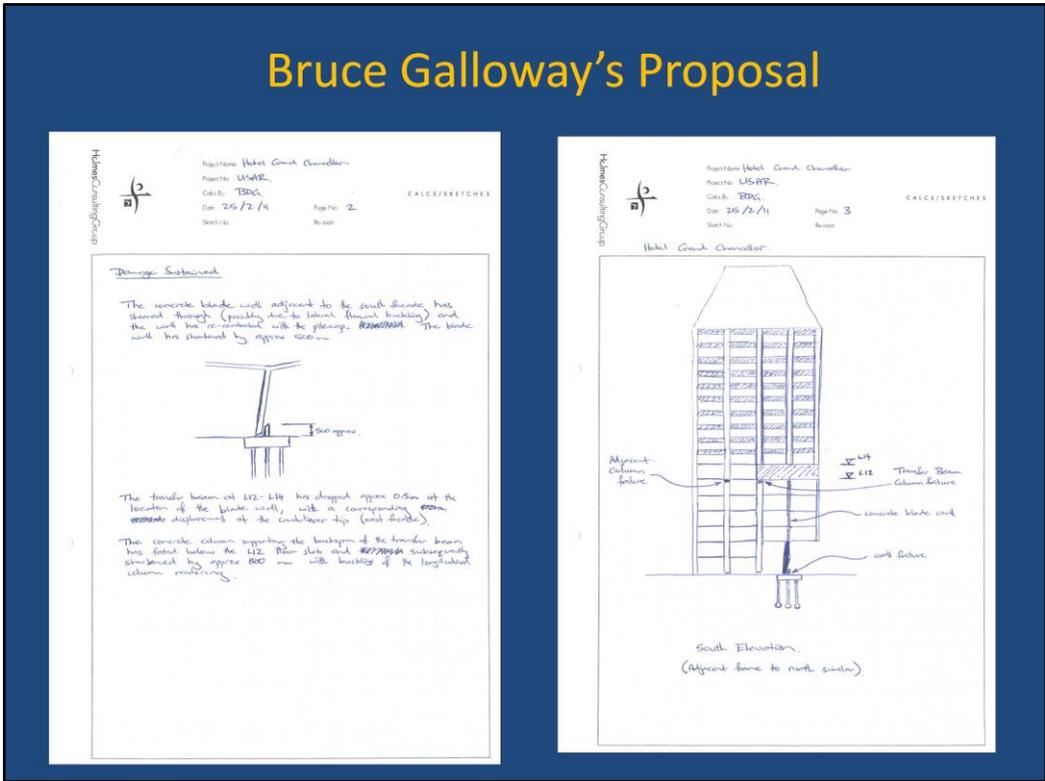
## Bruce Galloway's Proposal

Bruce Galloway's notes showed clearly the fundamental nature of the failure and its significance in the context of the structural form.

It seemed likely that a strong aftershock would collapse the building unless the failed wall could be strengthened or a means found to prop the cantilevers.

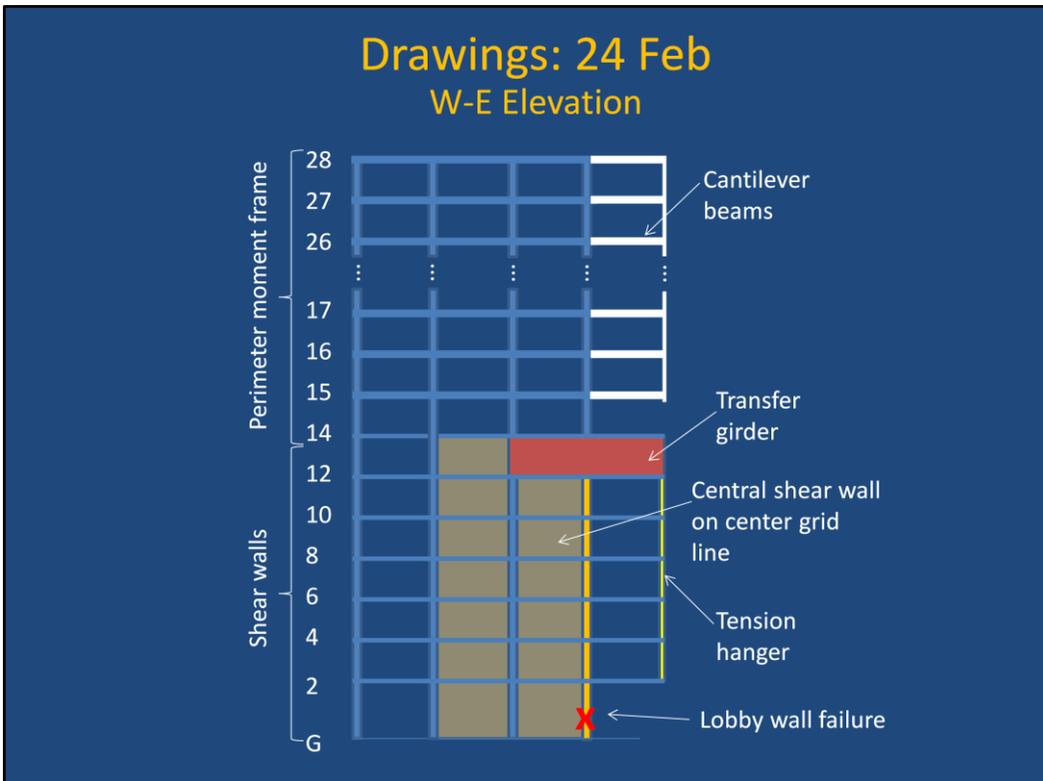
*Drawings 24 February*

The first 12 floors were in fact half floors for car-parking. This accounted for reports of a 28-storey building when it was equivalent in height to 22 normal storeys.

The critical position of the failed element is again apparent.

The 800mm drop in the shear wall in the foyer caused the storey-height cantilever to rotate and drop. Something else had to give. It was columns on Level 10.

It was as well that the failed wall was still carrying load – and stopped further collapse.

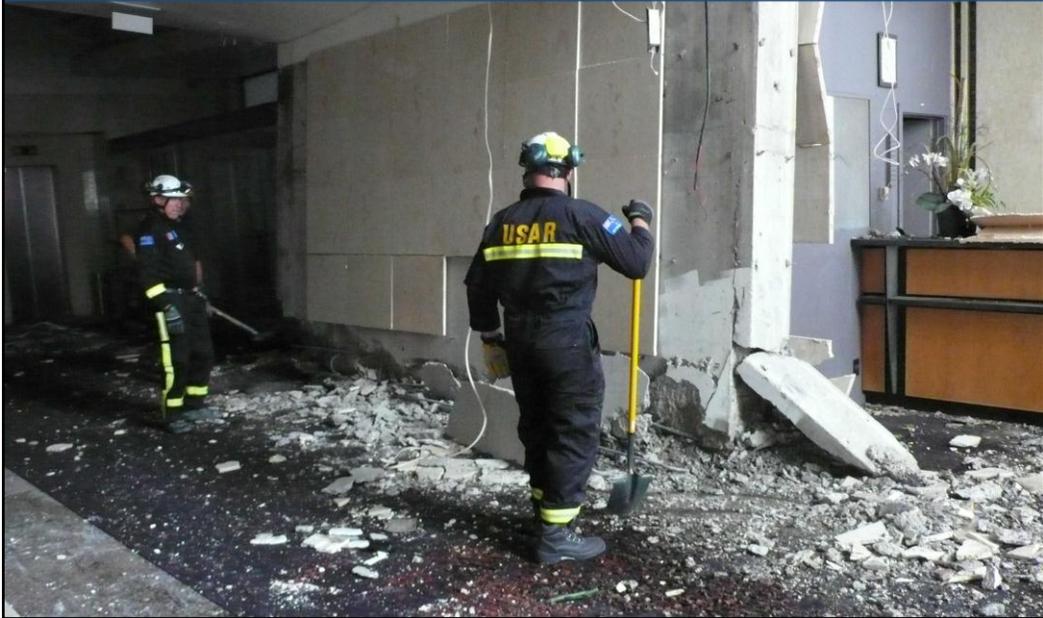
### *Clearing the work area*

USAR engineers clear the collapsed wall to make way for formwork and reinforcing.

This was dangerous and nerve-wracking work.

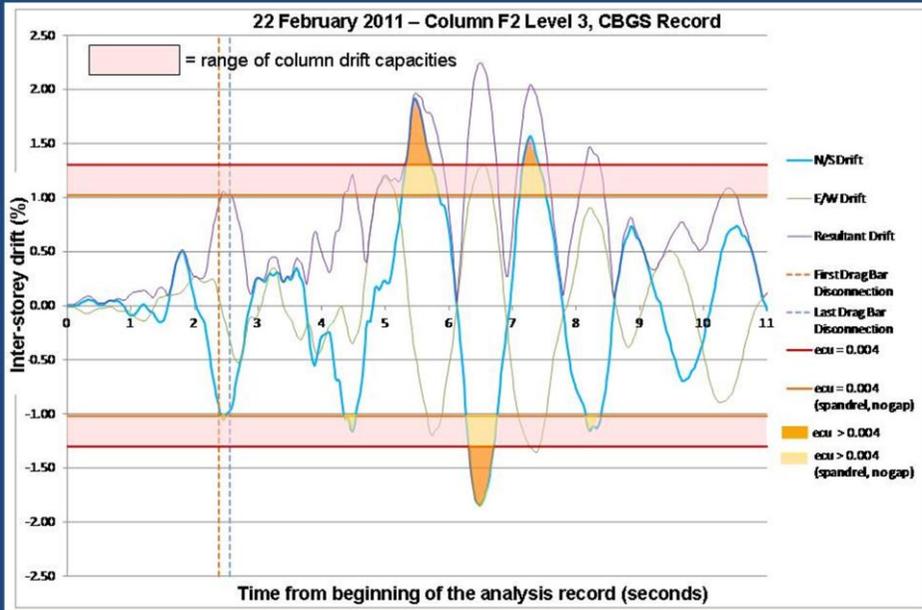
### Column F2 Level 3 22 Feb 2011

The strong horizontal ground accelerations on 22 February caused the floor movement (predicted by the analyses for one critical column) to be 90% more than 1986 design expectations and about double that in the 4 September event.

Comparison of drift demand and capacity

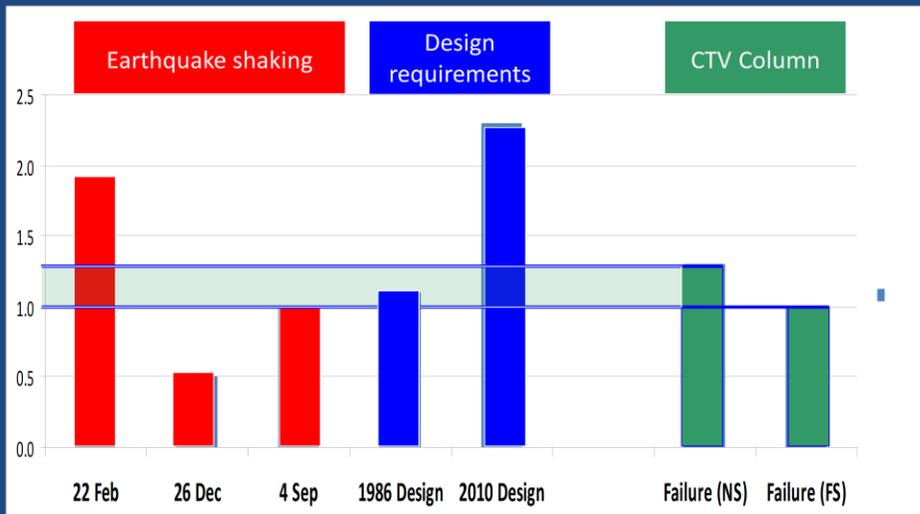
### *Column movement comparison*

This diagram compares estimated movements, capacities and design requirements for a potentially critical column. It provides some very useful insights into the collapse.

Design requirements for 1986 and 2010 for this column are shown in blue.

When compared to design levels it can be seen that 22 February event was much more demanding than anticipated by the 1986 Standard, but that current standards require allowance for displacements similar to those estimated for the 22 February event.

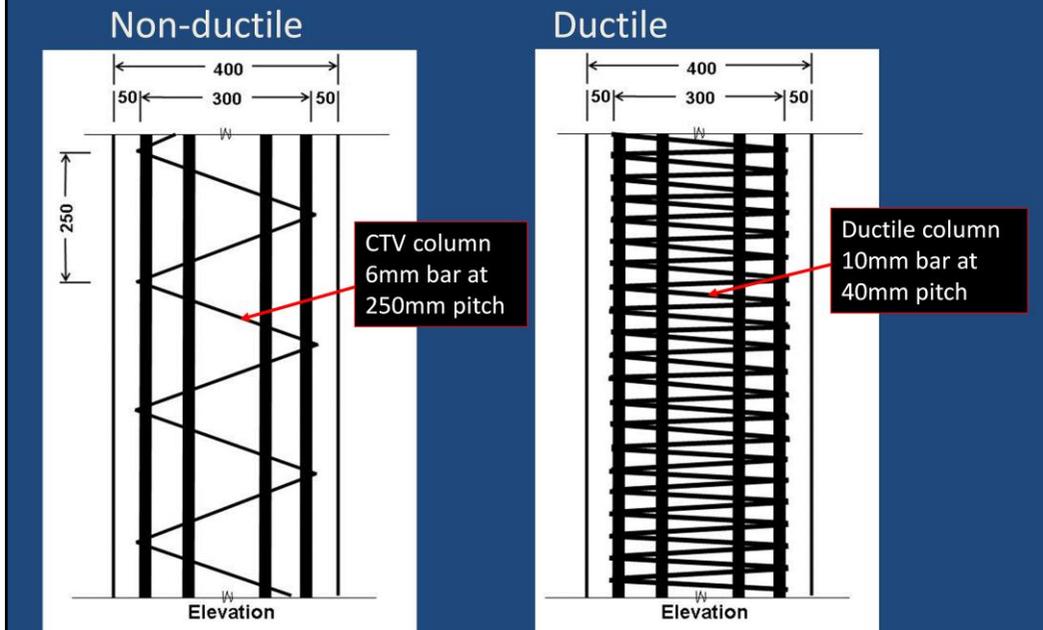
*Non-ductile vs ductile*

A pencil will flex when subject to bending action. But soon it snaps and has no strength. It is brittle.

Even in the non-ductile state a typical critical column was shown to be capable of absorbing about two-thirds of the floor movements caused by the 22 February event.

However, once the limit was exceeded, there is nothing to hold the column together and it immediately loses all capacity to carry vertical load.

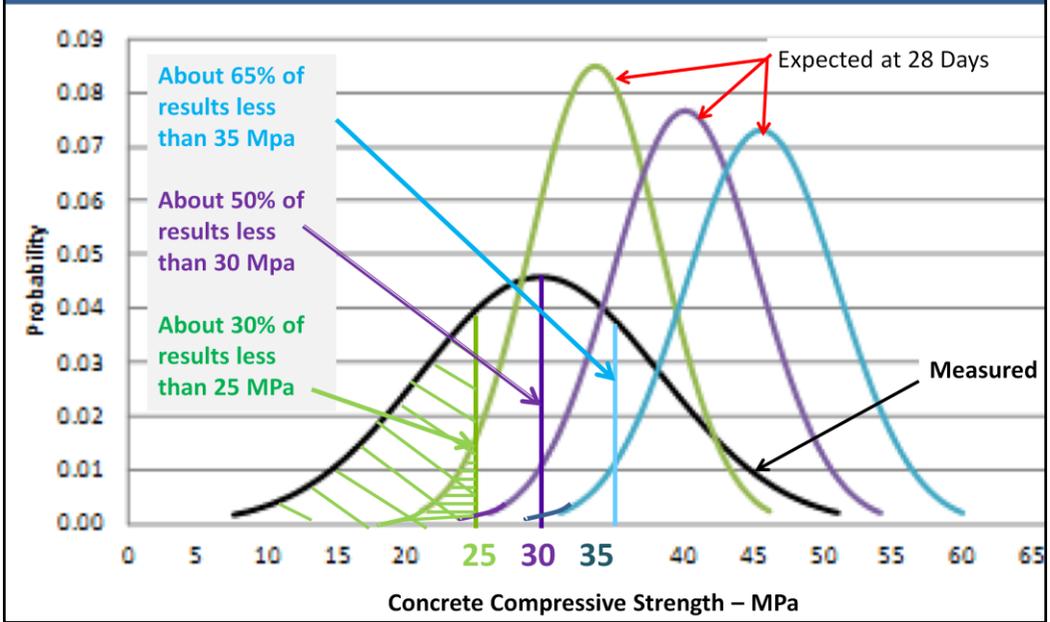
Concrete strengths

Low concrete strengths in samples from critical columns

Tests on 26 column samples showed lower than expected results. It is not known which levels the samples came from – the reinforcing details were the same at each level.

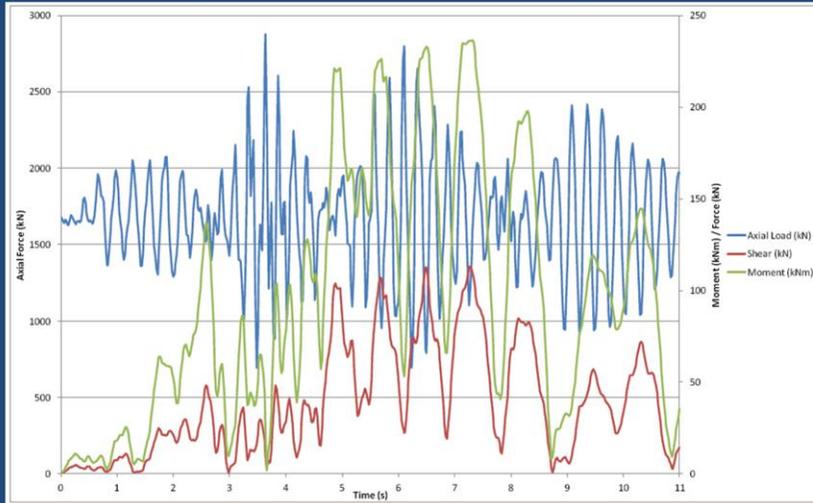
### Column actions D2 Level 3 – 22 Feb 2011

- Affected load on columns - up to double the compression
- Extra compression reduces lateral movement capacity

This means that there is a high chance of having large compression at the time of large displacement – even if the peak values do not coincide.

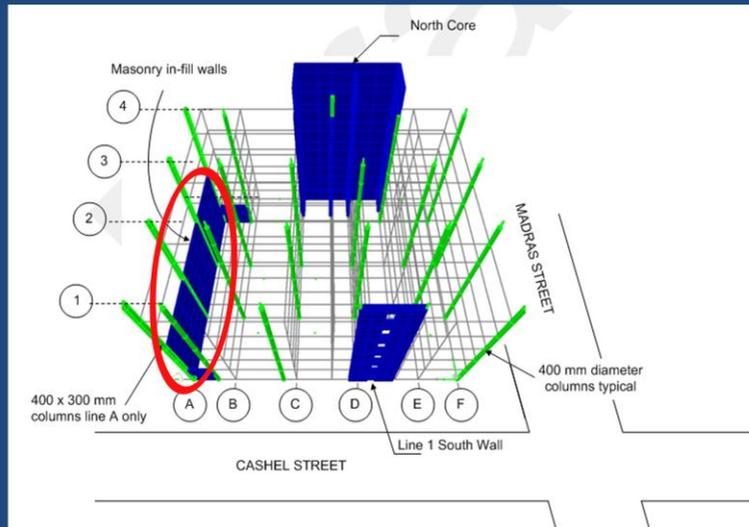
## Structural influence of masonry walls

- ***The masonry walls*** were found to have some effect on floor movements but these were not as significant as expected.

- Increased displacements Level 3 to 4

### *Structural influence of masonry walls*

These walls were intended to be separated from the structure but this was not fully achieved.
